# Manhole Inspection Summary

Manhole # S47CC\_043MH

Insp Date: **2/4/08 1:44 PM**

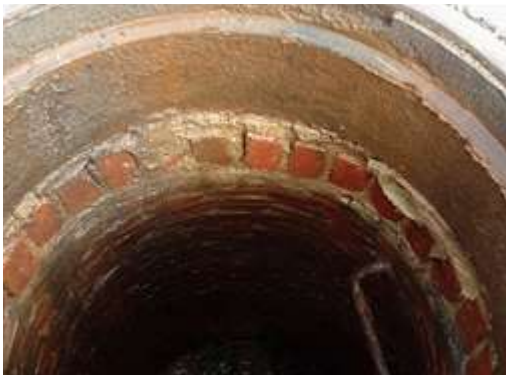
Defect 1

☒ **Leaks**

Frame Leaks

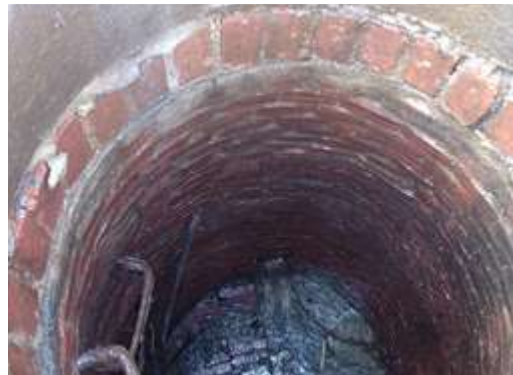
Defect 2

Infiltration: ☐ None ☐ Joint ☐ Cracks ☐ Mortar ☐ Roots ☒ **Wall**

infiltration

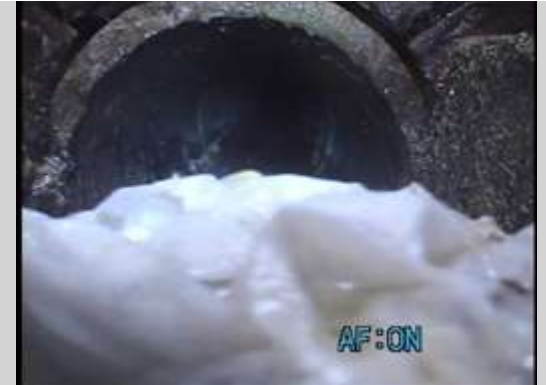
**12 O'Clock Outflow**

Pipe Height: **10.8** (in.) Rod and Bar (Angled)  
Pipe Material: **Clay** ☐ Pipe Lined  
Invert Depth: **11.00** (ft.) Flow Characteristics: **Fast**  
Deposits: ☒ None ☐ Mud ☐ Sludge ☐ Debris ☐ Grease  
Silt Depth: (in.) Deposits Extent:  
Infiltration: **None** Pipe Seal Cond: **Sound**

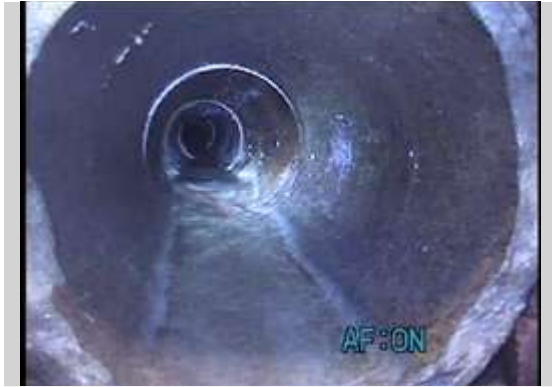
Pipe In @ 9 O'Clock

Invert Depth: **9.30** (ft.) Flow Characteristics: **Fast**

Infiltration: **None** Pipe Seal Cond: **Sound**

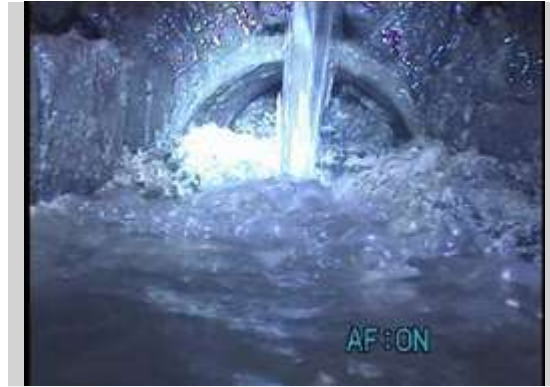
Drop In @ 9 O'Clock

Drop: **Outside Rod and Bar**

Drop Condition: **Clogged**
